Disposal Area Monitoring System DAMOS

**CAPPING SURVEY AT THE
NEW LONDON DISPOSAL SITE
FEBRUARY 3, 1989**

CONTRIBUTION #71

**Report No.
SAIC-89/7554&C76**

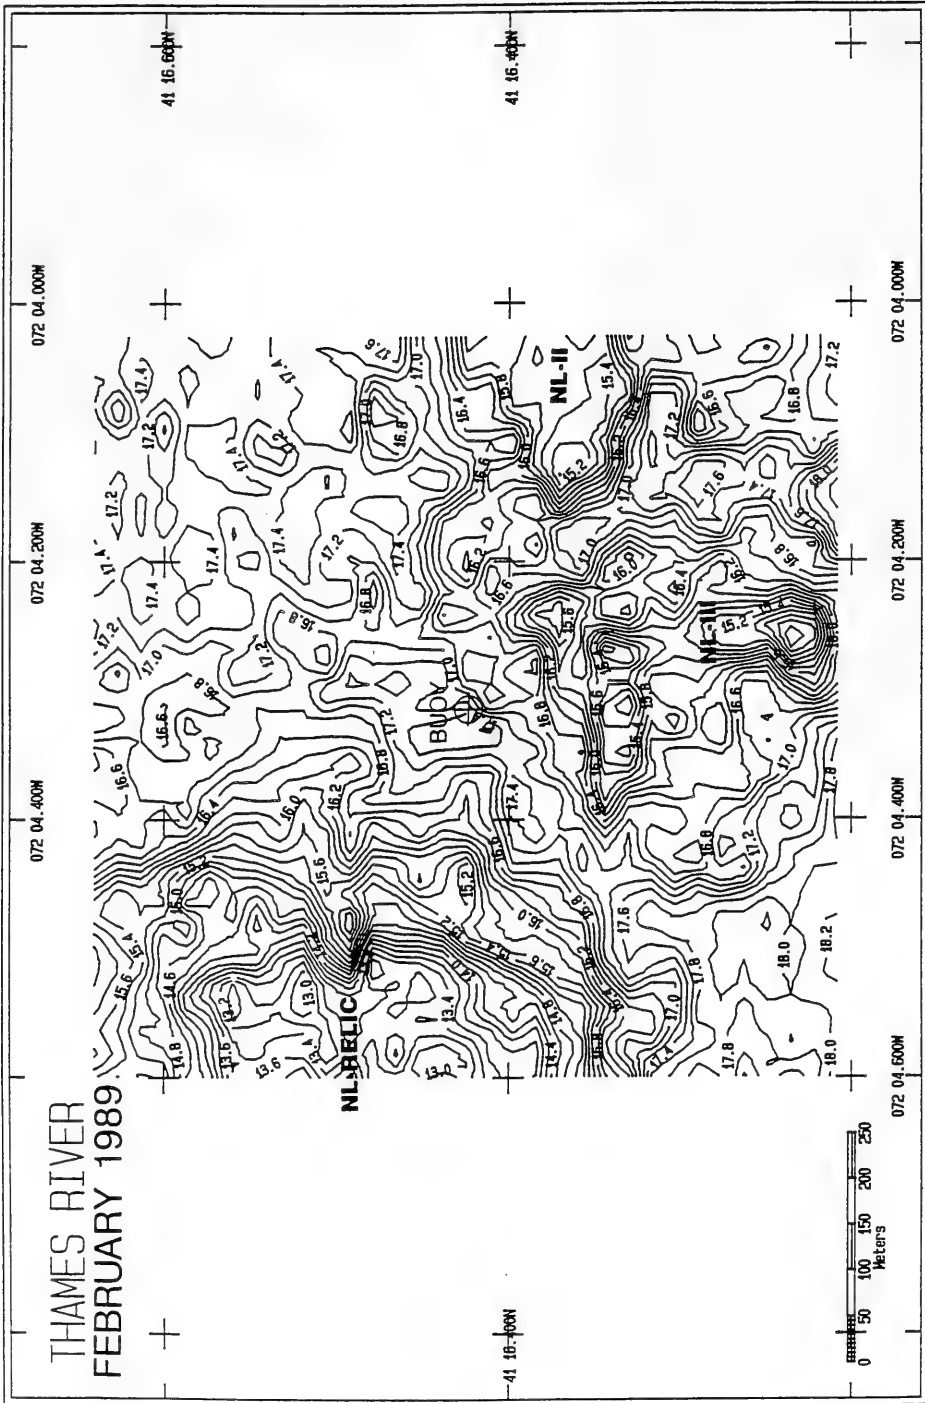
Figure 1 Post-capping bathymetric contour plot of the Thames River Shipyard Disposal Location, February 1989. Contours at 0.2 m intervals.

The contour plot from analysis of the 1989 bathymetric data revealed a highly variable topography of old disposal mounds resulting from dredged material disposed in previous years, as well as from cap material disposed at the buoy location (Figure 1). The clearly visible north-south contours running along the western border of the survey area delimited the eastern flanks of the old disposal mound NL-RELIC. The NL-III mound was seen along the southern border of the survey area. The western flanks of the NL-II mound were also shown on the eastern limits of the survey area. Changes in topography resulting from capping material deposition were indicated by comparison of this contour plot with the results of the October 1988 post-disposal survey (Figure 2).

Most of the capping material was evident in the area to the southeast of the buoy. At roughly 150 m south of the buoy, the cap layer showed a minimum depth of 14.8 m, in comparison to the 1988 minimum depth of 15.5 m at this location. Another topographic high of 15.6 m was detected 140 m southeast of the buoy in the 1989 contour plot, 0.6 m higher than the 16.2 m shown at this location in the 1988 contour plot. While this capping layer was relatively steep-sided in parts, it showed several isolated topographic highs. This reflected both the areal extent of the underlying disposal mound as well as a spatial variation in cap thickness ranging from 10 to 70 cm. It should be noted that in 1988 the western part of NL-II showed a minimum elevation of 15.5 m, whereas in 1989 the very western part of the mound showed a minimum elevation of 15.2 m. This indicated an extension of the cap layer to the edge of NL-II with a thickness of approximately 30 cm in this area.

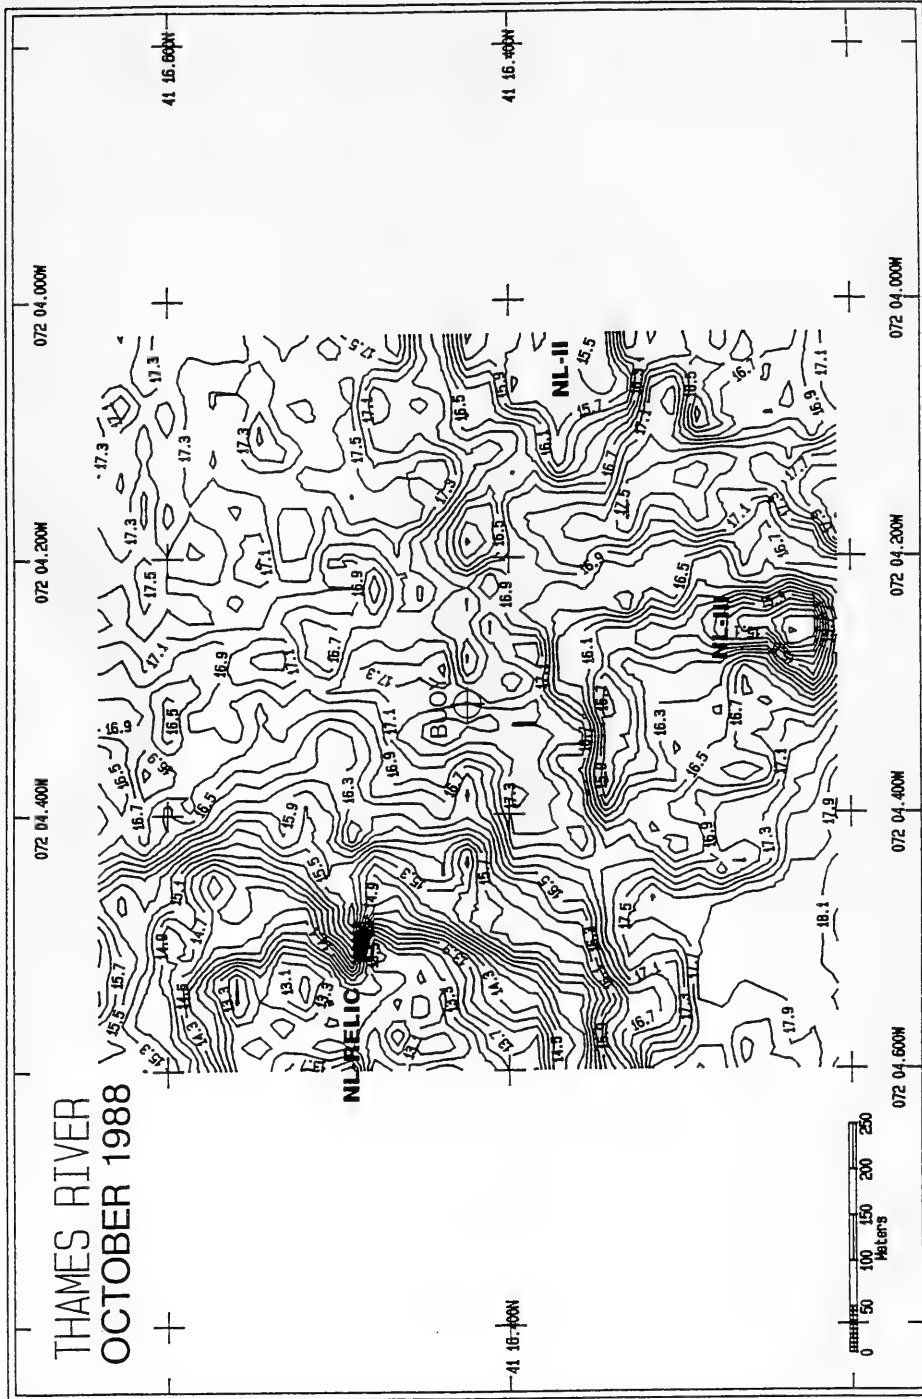
Figure 2 Post-disposal bathymetric contour plot of the Thames River Shipyard Disposal Location, October 1988. Contours at 0.2 m intervals.

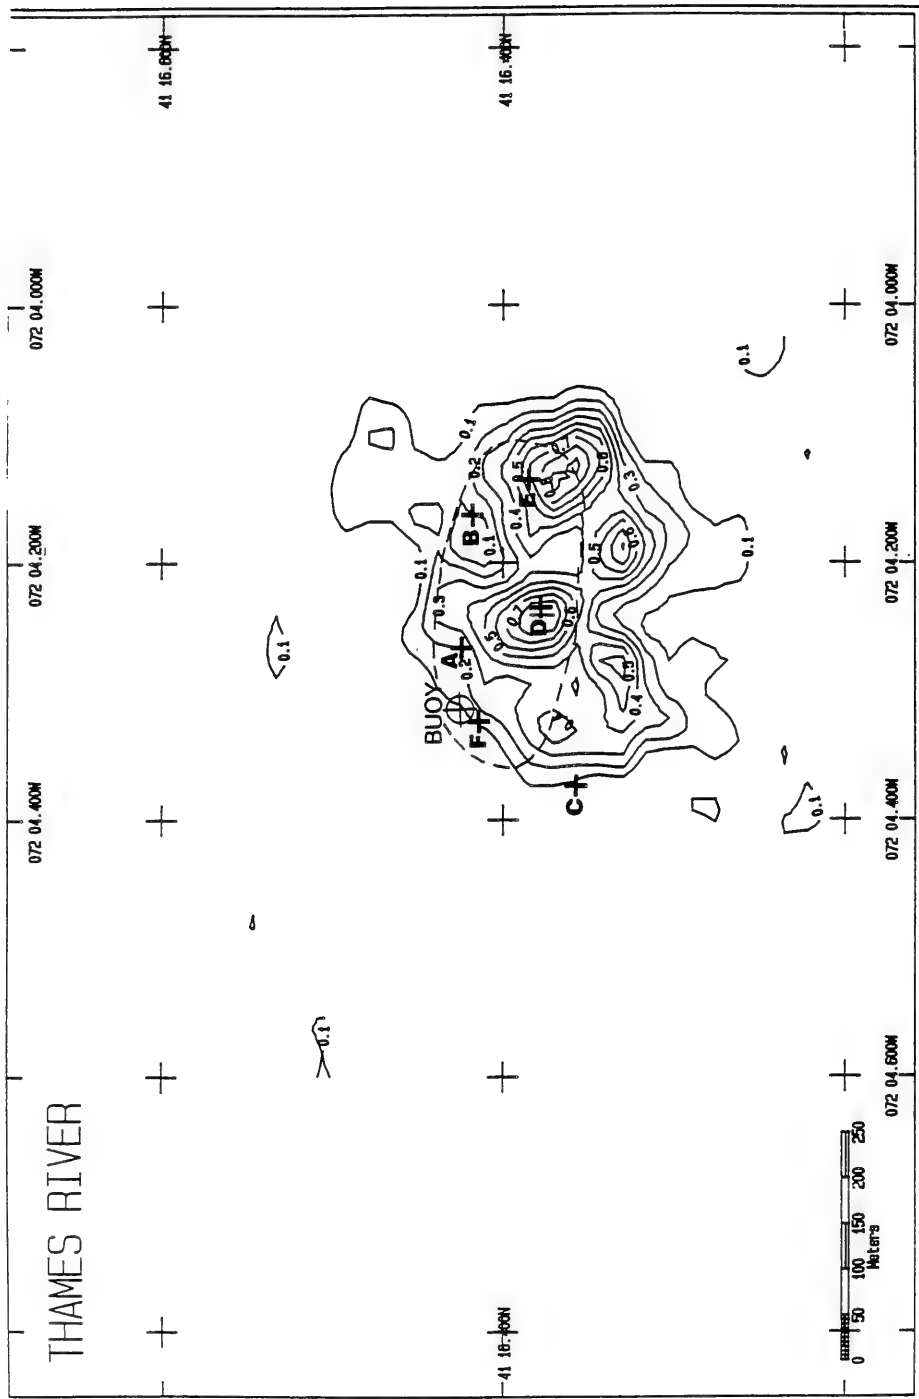
Figure 3 Depth difference contour plot of the Thames River Shipyard Disposal Location, showing the distribution of cap material, February 1989 - October 1988. The dashed contour line indicates the mapped distribution of contaminated dredged material as detected by the REMOTS survey of October 1988. Points "A" - "F" are the disposal point locations recommended in the Thames River Shipyard capping plan (SAIC, 1988).

To determine cap thickness a depth difference plot was prepared by subtracting the depth matrix of the October 1988 bathymetric survey from that of the February 1989 survey (Figure 3). The cap material clearly showed a roughly circular and continuous distribution varying in thickness from 10 to 80 cm. This depth difference comparison resulted in a calculation of 28,270 m³ of cap material detected at the site. According to scow log records an estimated 59,517 m³ of cap material was deposited between October 1988 and January 1989 (Table 2).

Examination of the distribution of cap thickness in relation to the six recommended disposal points revealed that cap material was clearly deposited at points "D" and "E". These were the locations of the two thickest parts of the cap layer, having cap material accumulations of 80 cm (Figure 3). Cap thicknesses of 50 to 60 cm were also established to the southwest of these two disposal points. However, point "A" was intended to have received the most scow loads of cap material because of the contaminated dredged material thickness at this point (Table 1). The depth difference contour plot indicated only 20 cm of cap material here. At disposal points "B", "C", and "F" only 10 cm of cap material appeared to have been deposited (Figure 3).

The erratic topography of the cap layer generally reflects the spatial distribution of the recommended disposal points (Figure 3). However, detected cap thicknesses surrounding these locations suggests a consistent shift in cap material deposition to the southeast. The largest volumes of cap material were reportedly disposed of at points "A" and "B" (Table 2). However as already noted, the two thickest parts of the cap layer actually detected are located at points "D" and "E". These points are offset to the southeast of points "A" and "B". Similarly at point "F" little cap material was indicated in the depth difference contour (Figure 3), yet a localized cap layer of 40 cm was detected just south of this disposal point. Similar topographic highs in the cap material distribution were indicated south of disposal points "D" and "E" (Figure 3). This suggests that some offset was consistently

affecting the positioning accuracy of cap material deposition during the capping operation. Most likely this was due to a consistent Loran error, resulting in the cap layer effectively covering the majority of the contaminated dredged material with the exception of the northern and western borders of its distribution.

It appears that additional capping material is required at certain locations along the northern and western borders of the disposal mound. It is recommended that additional material be deposited at locations "A", "B", "C", and "F" in order to cover the contaminated material with a sufficiently thick layer of clean material (between 50 to 100 cm). However, because of discrepancies between the recommended disposal point locations and the actual distribution of cap material detected, it is recommended that

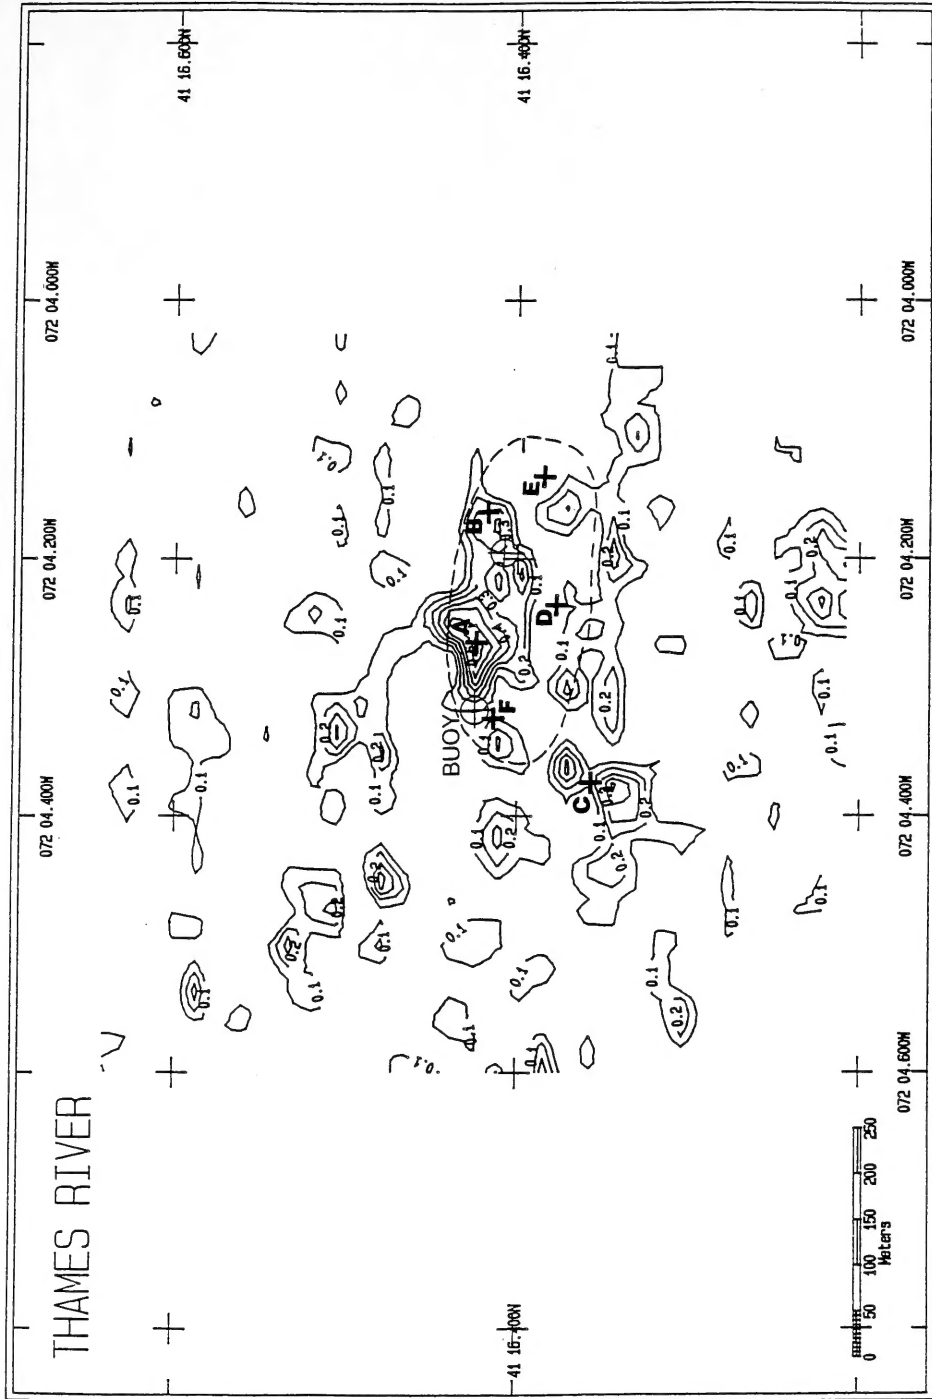
Figure 4

Depth difference contour plot of the Thames River Shipyard Disposal Location, showing the distribution of contaminated dredged material, October - August 1988. The dashed contour line indicates the mapped distribution of contaminated dredged material as detected by the REMOTS survey of October 1988. Points "A" - "F" are the disposal point locations recommended in the Thames River Shipyard capping plan (SAIC, 1988).

Depth difference calculations from the pre- and post-disposal bathymetric surveys of contaminated material revealed the distribution of material requiring capping (Figure 4). The mapped distribution of dredged material indicated from the REMOTS® survey of this area conducted in October 1988 confirmed this distribution detected by bathymetric techniques, and extended it roughly 50 m to the south, east and west (SAIC, 1988). Superimposing this distribution of dredged material as detected by the REMOTS® survey of October 1988 over the cap distribution detected in 1989 again confirmed that most of the contaminated material did receive some cap material (dashed line, Figure 3). However, at disposal point "A", 70 cm of contaminated material apparently received only 20 to 30 cm of cap material (Figures 3 & 4). In addition, at disposal point "F" 10 to 20 cm of contaminated dredged material was apparently capped by only 10 cm of clean material based on the 1989 bathymetric depth difference plot (Figure 3).

The depth difference plot from the pre- and post-disposal bathymetric surveys of contaminated material indicated a small deposit located roughly 150 m southwest of the buoy (near point "C", Figure 4). Although this material fell outside the mapped distribution of dredged material verified by the 1988 REMOTS® survey, it was recommended that this deposit be capped in addition to the main disposal mound because of the substantial amount of material detected here in the depth difference comparison (SAIC, 1988). This location should have been covered by scow loads of cap material deposited at point "C". However, the 1989-1988 depth difference plot indicated little or no cap material at this location. It should be noted that bathymetric surveys are limited in their ability to detect thin layers of sediment typical of disposal mound flank deposits. Thus, it is likely that the actual borders of the cap layer extend further than indicated in the bathymetric depth difference contour plot, covering locations such as disposal point "C". However it is unlikely that such flank layers would be thicker than the minimum change in depth detectable by bathymetric techniques (10 cm).
